SPECIAL REPORT ON ANADROMOUS STREAM SURVEYS OF CLEVELAND
PENINSULA, INCLUDING EMERALD BAY, VIXEN INLET, UNION BAY,
CLARENCE STRAIT, BOND BAY, SPACIOUS BAY, AND PORTIONS OF
PORT STEWART AND HELM BAY

Subdistricts 107-10 and 102-80

March 1985

Alaska Department of Fish and Game
Division of Commercial Fisheries
Petersburg, Alaska

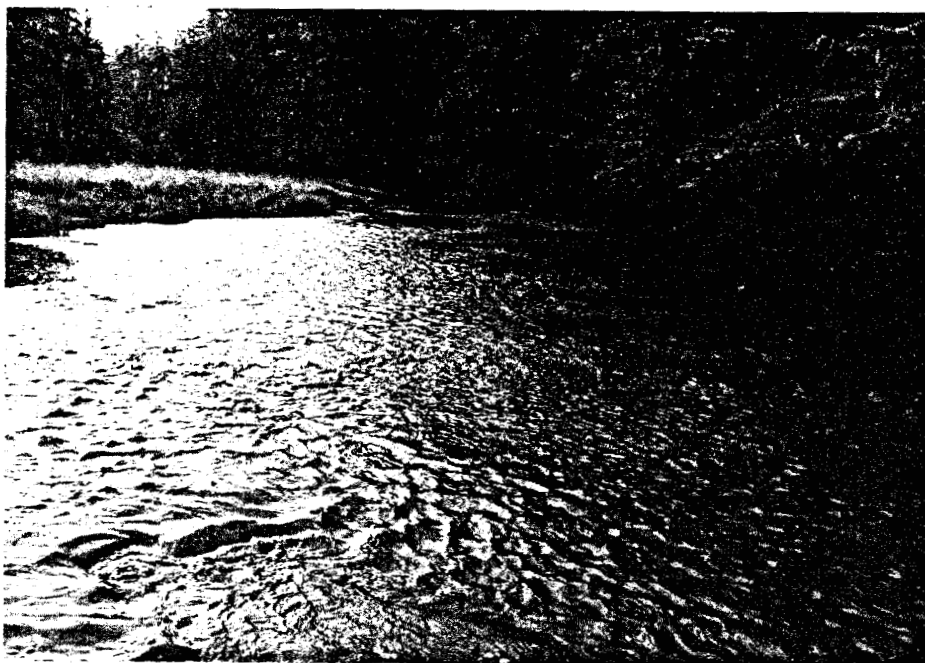
1. Upper ITZ. Excellent ASA.

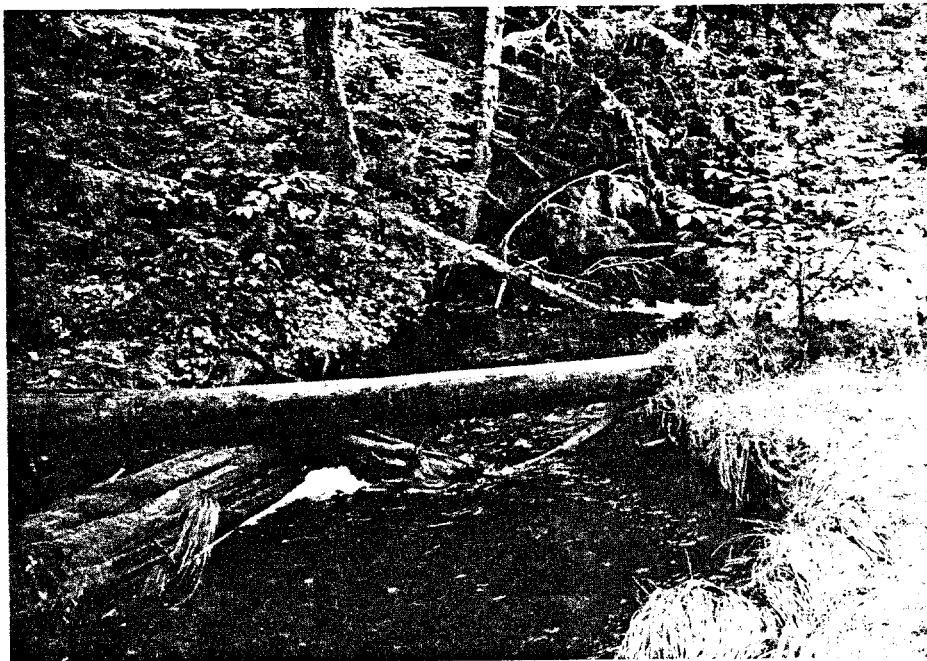
3. A braided channel which runs along the left bank from Section #3 to Section #7. This photo was taken at the lower end.

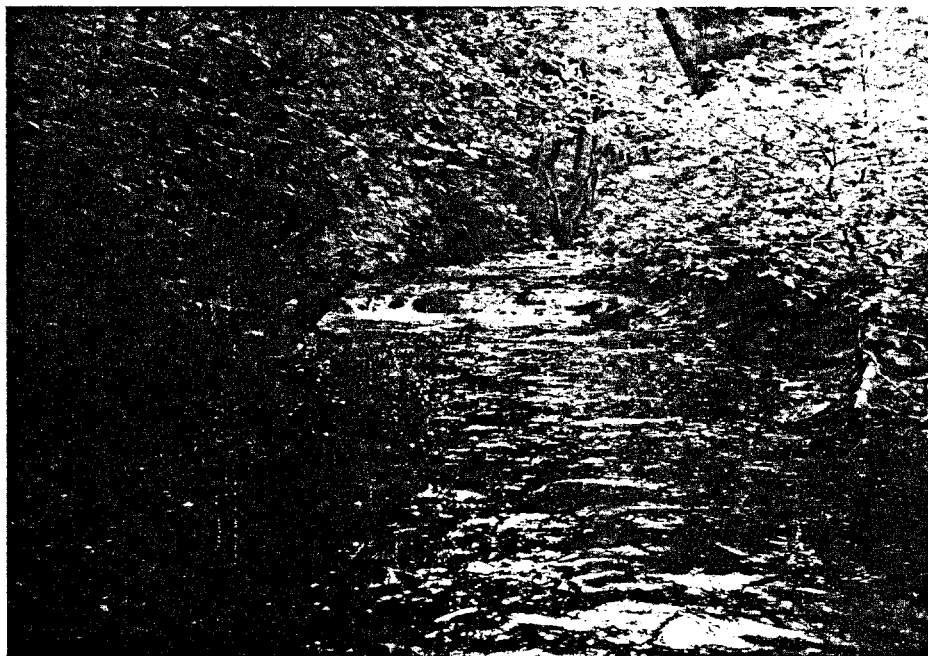
4. 75 m. into Section #6.

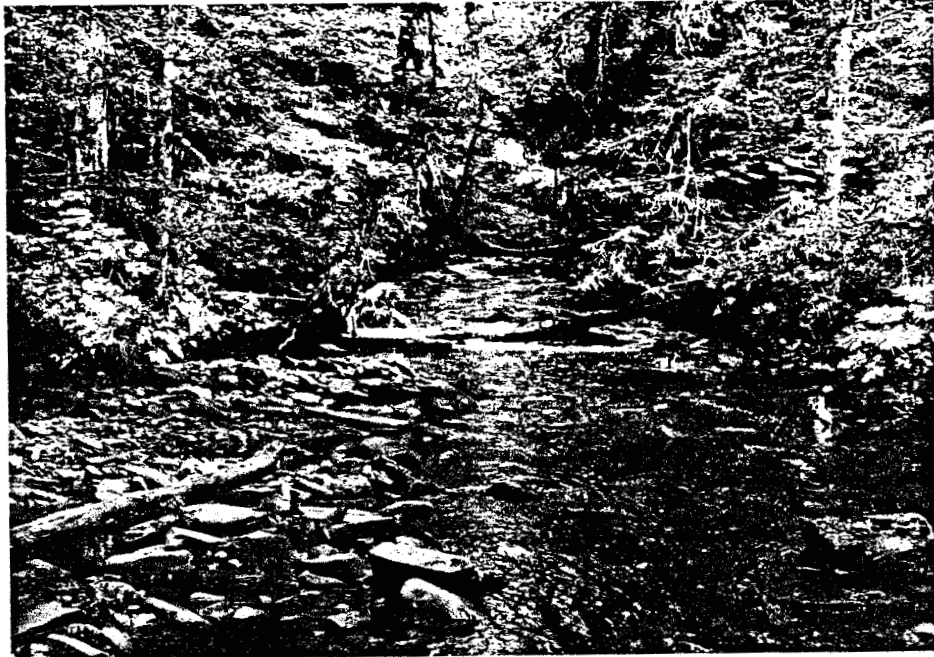
5. Section 9.

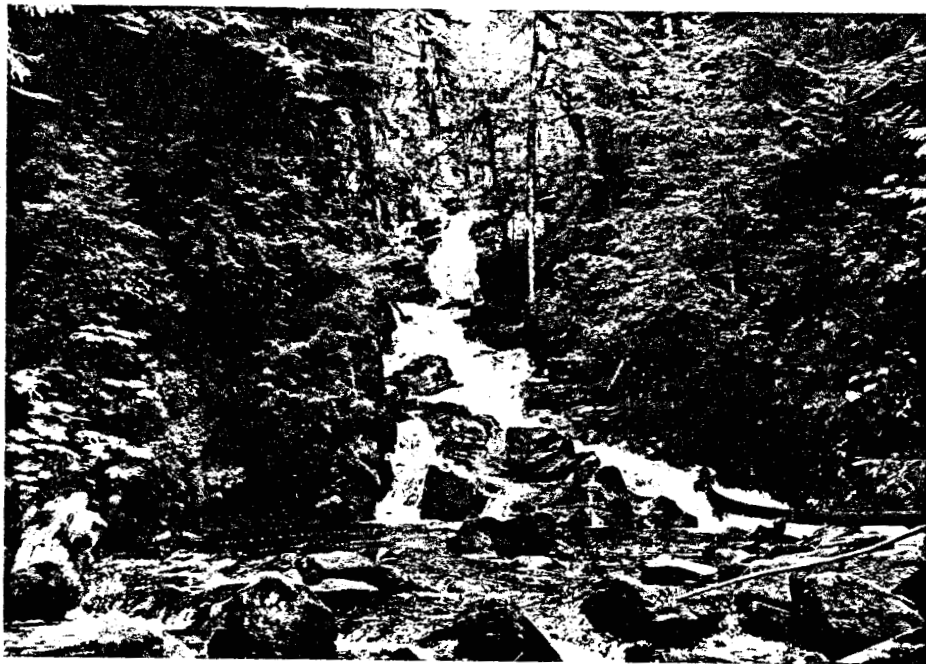
6. 30m. barrier falls in Section #10.

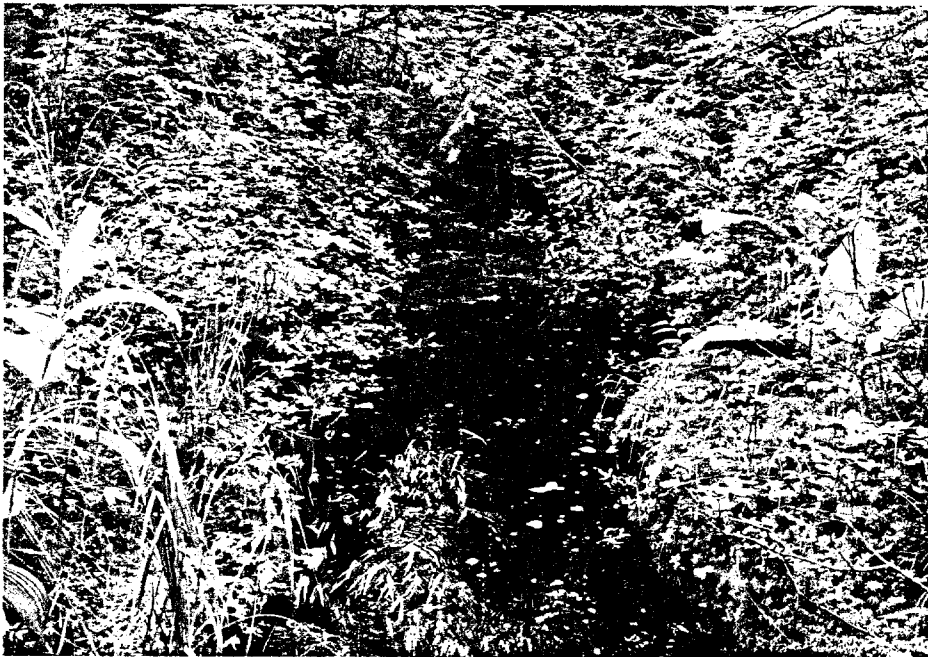
2. Section 11.

Section 11: Survey discontinued at end of Section. About 50 m. beyond Section 11 is a large active beaver dam area. No rearing fish have been observed since Section 8. No rearing fish are observed or sampled above the beaver dam.

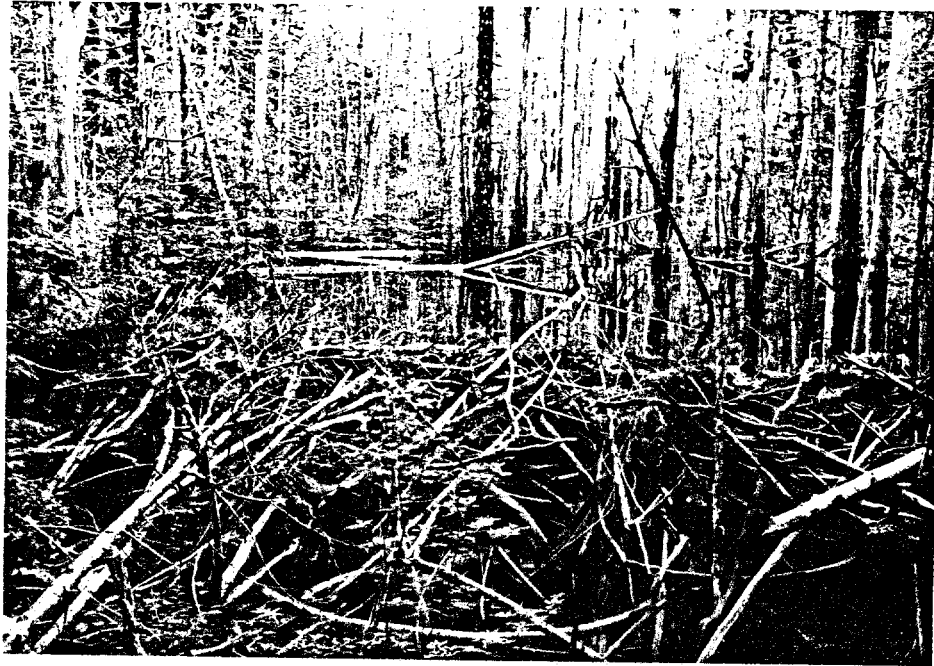
3. Section 3: Beaver dam 50 m. into Section #12

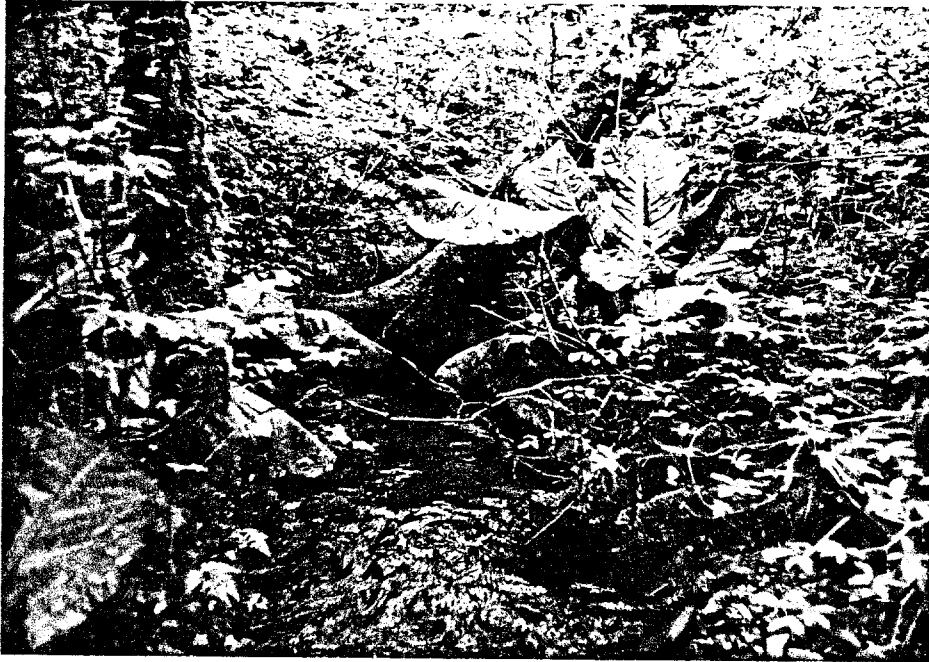
Emerald Bay #1 has several potential barriers within 30 m. of the ITZ. The stream goes under a bank and 1m debris/bedrock falls is present. The substrate is predominately large flat cobble. There is little ASA or rearing habitat. No rearing fish were observed. The stream goes to a 10% gradient within 50 m. The stream is .6 to 1m wide and averages 8-cm deep. Evidence of highwater discharges were present on the banks.

1. Typical habitat in the first 50 m.

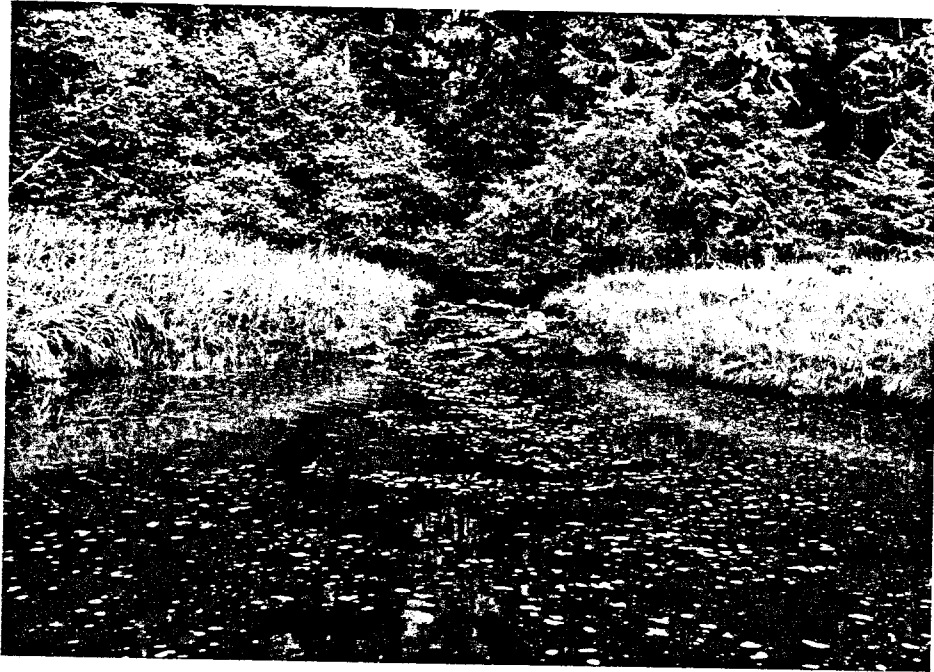
1. ITZ.

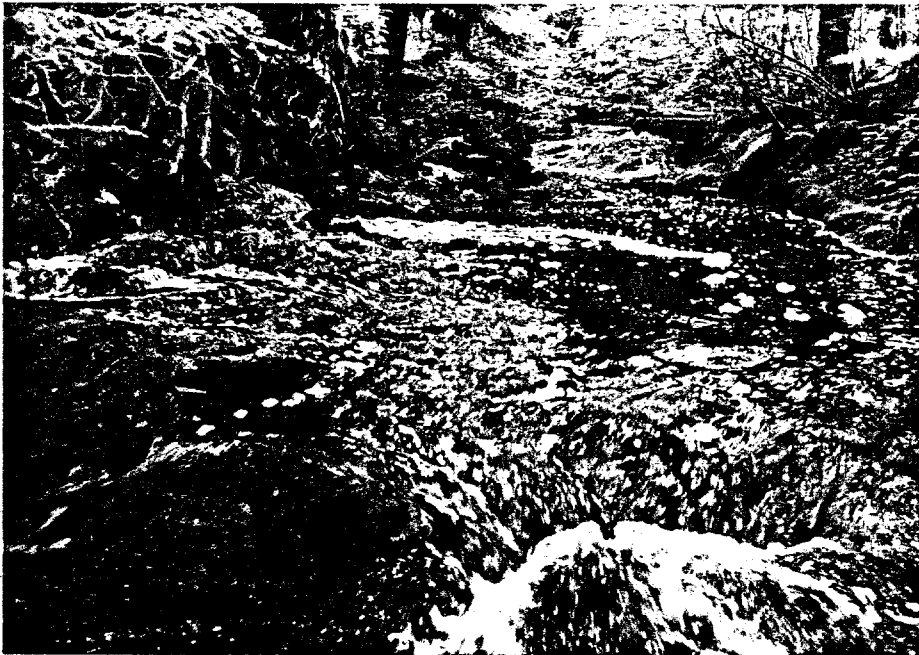
2. 60 m. into Section #2

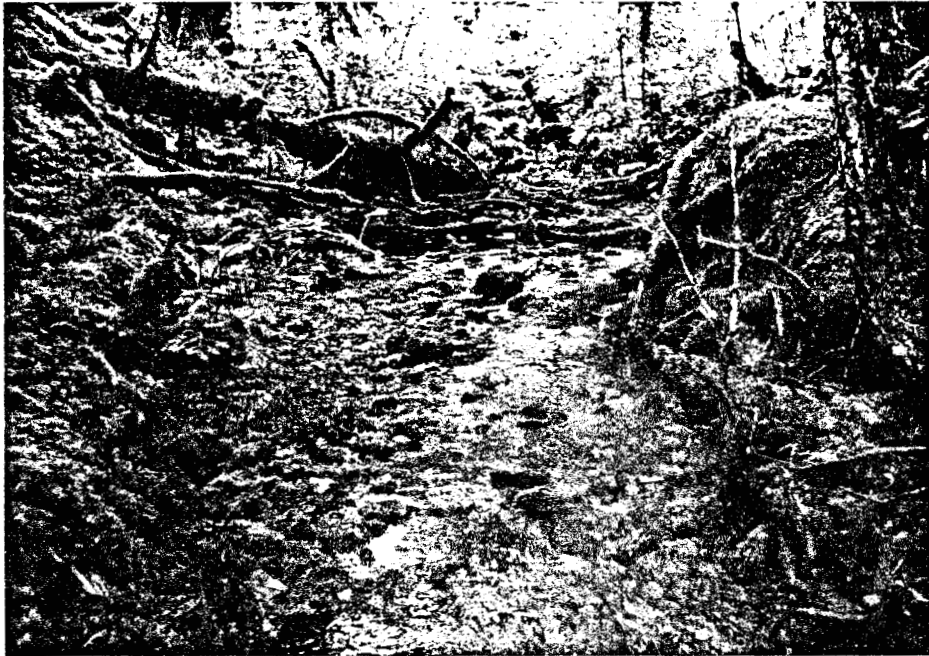
1. 100 m. from the ITZ.

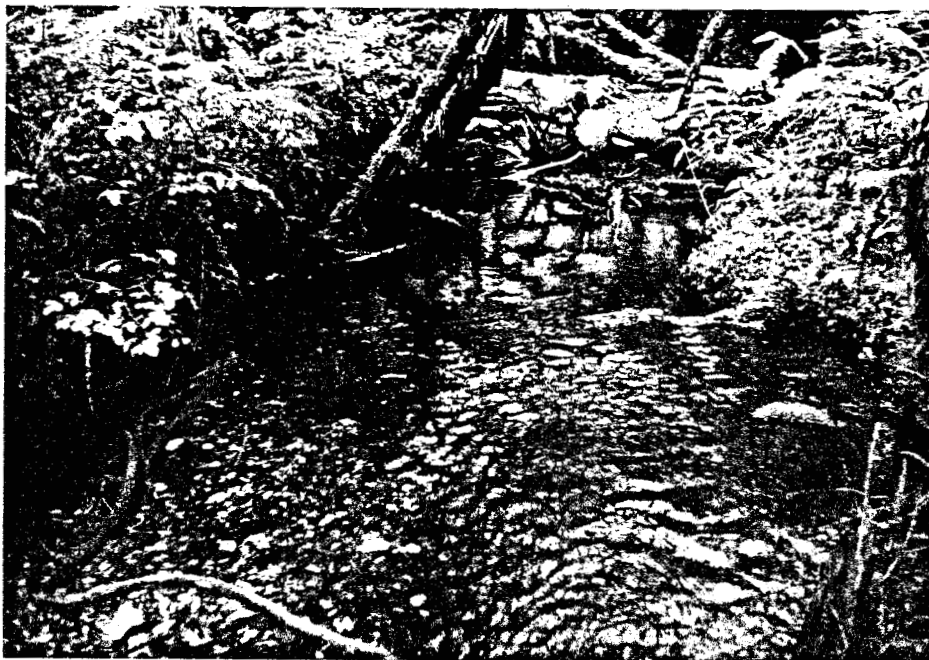
1. Gravel available 40 m. from ITZ. Shallow water may limit its accessibility, however.

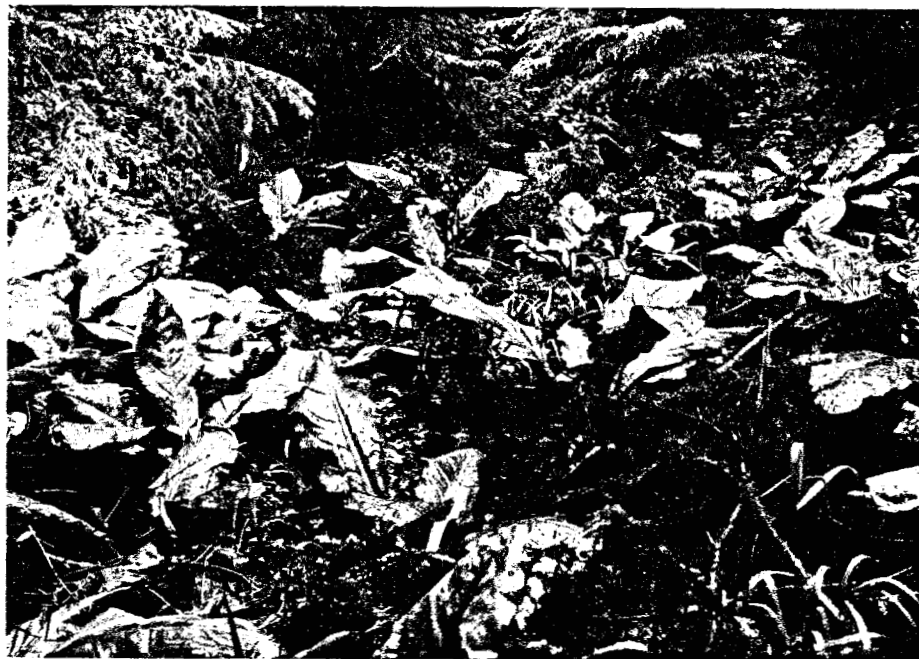
2. The stream enters a swamp area 50 m. from the ITZ.

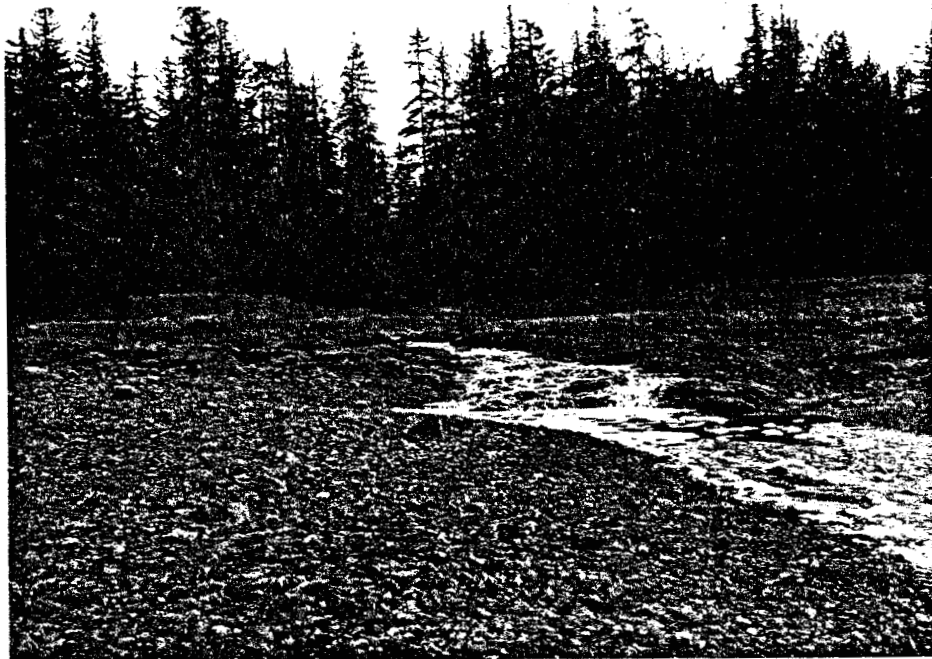
1. ITZ: The boulder/bedrock substrate provides poor ASA.

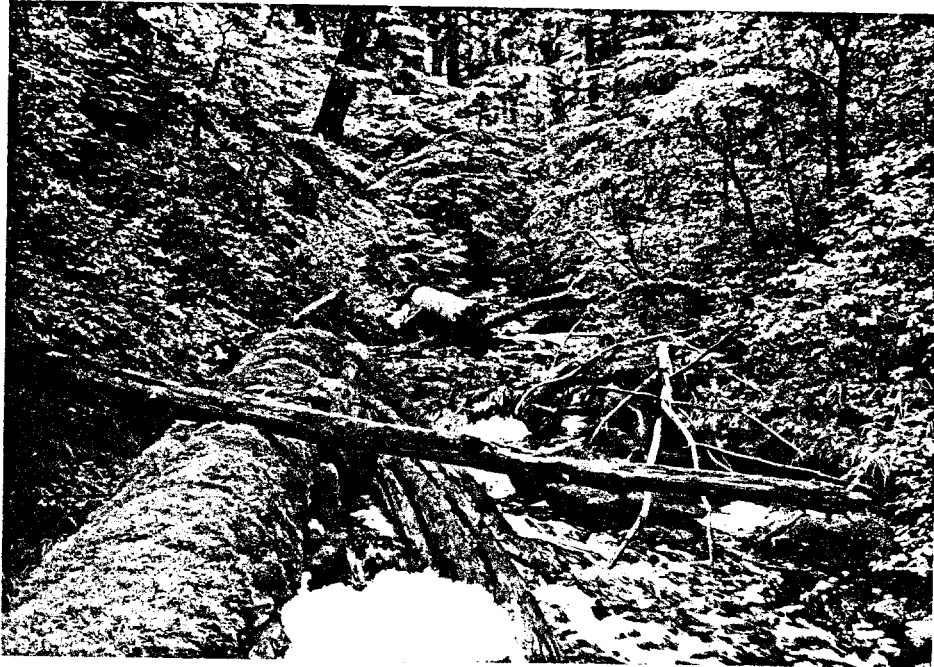
3. Section 8: The gradient increases in Reach 2, with a lowering in the quality of the ASA and rearing habitat.

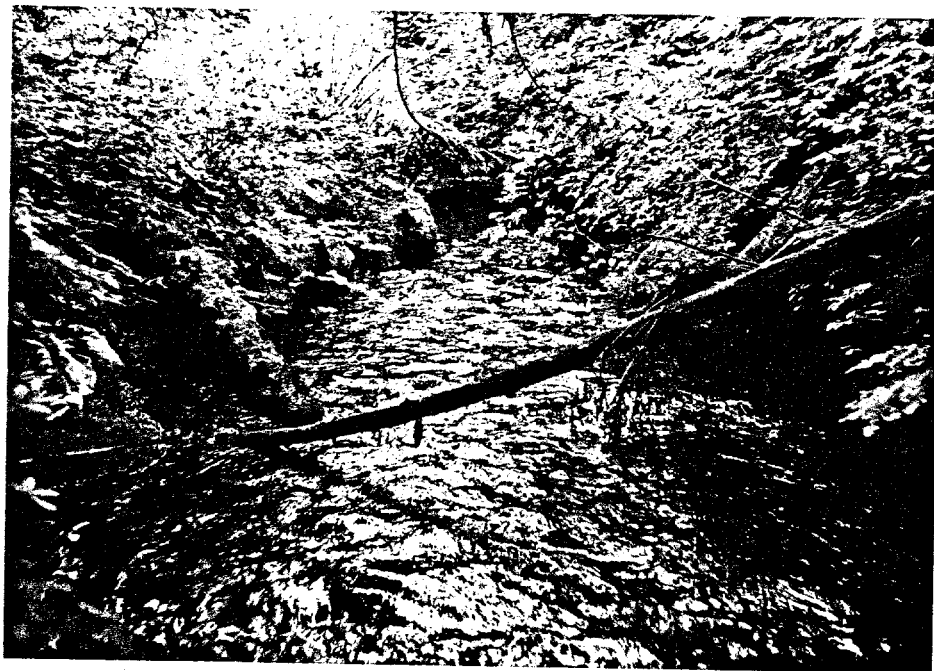
4. Section 12: The gradient decreases in Reach 3. The moss growth becomes dense on the substrate.

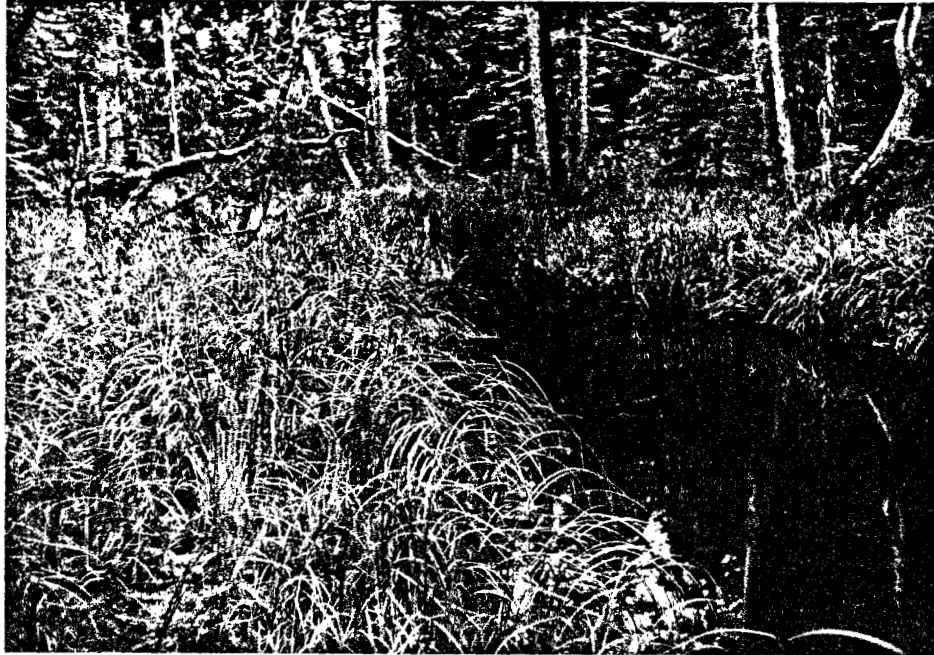
5. The survey was discontinued at a beaver pond beyond Section 14.

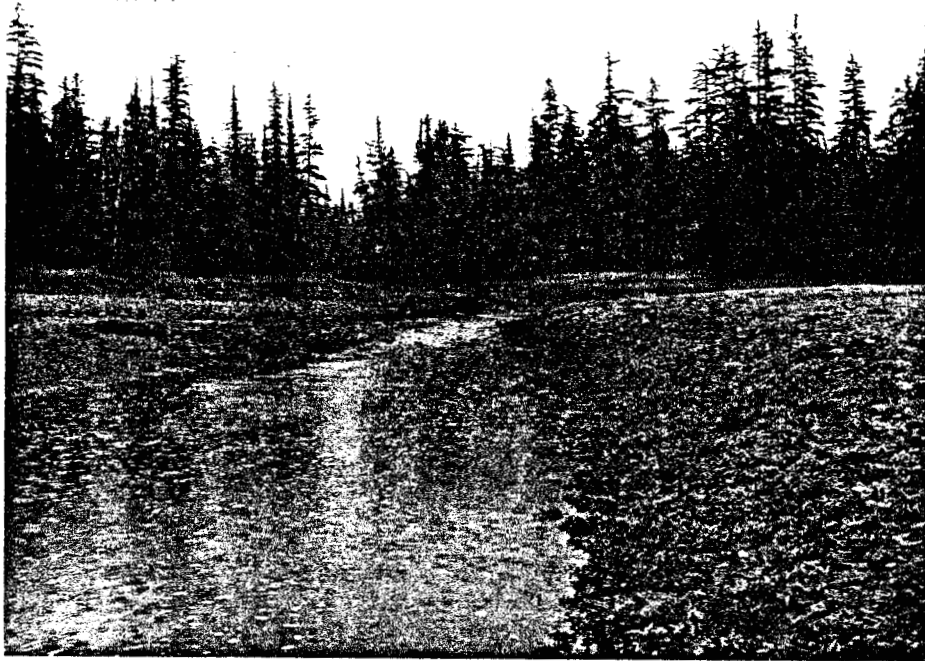
1. Lower ITZ. The upper ITZ is predominately bedrock.

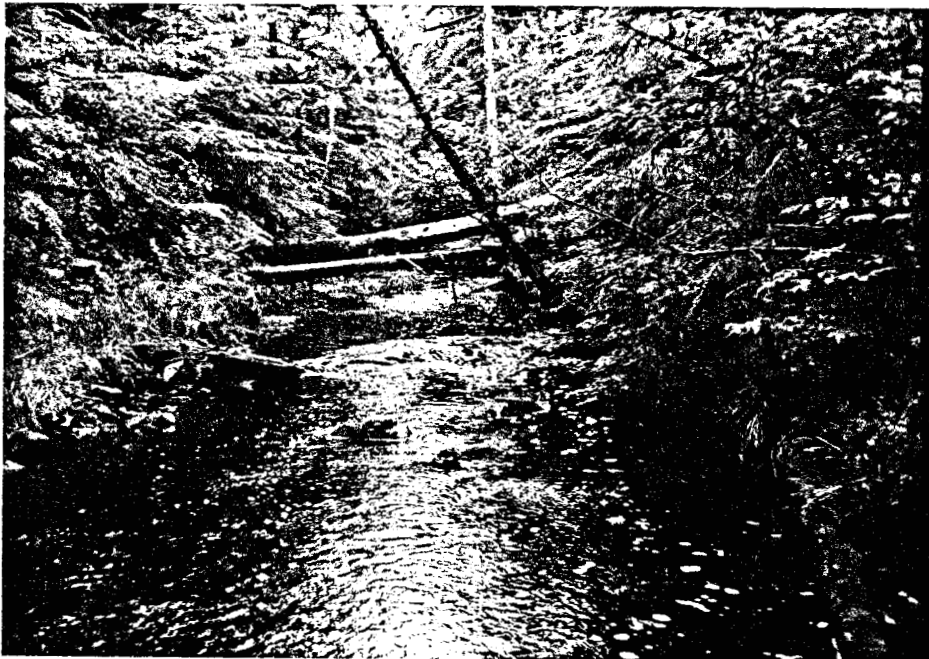
2. The substrate is 50% bedrock in Section 2.

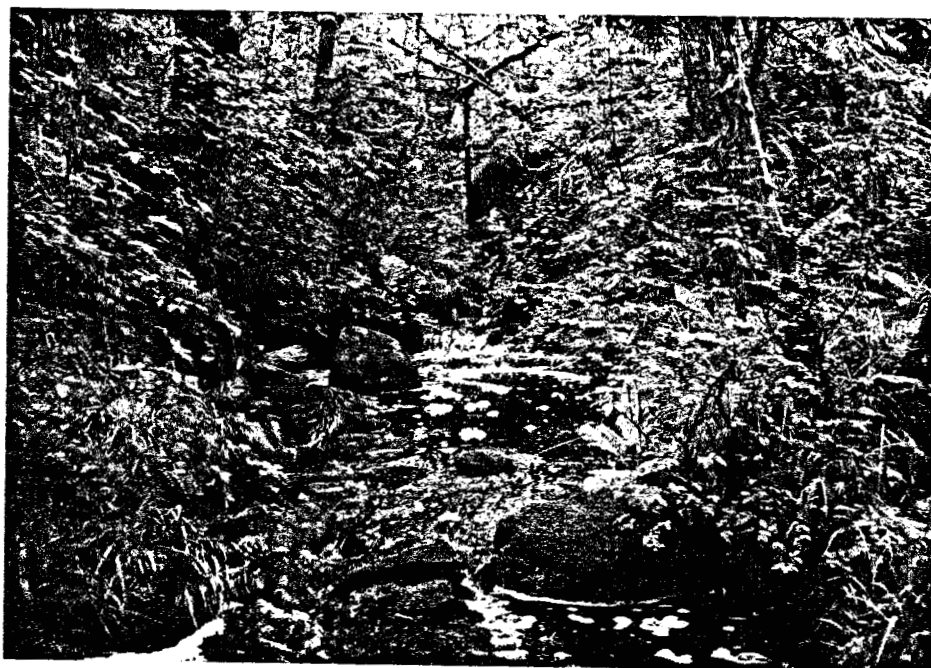
4. The fisheries habitat is minimal quality 100 m. beyond Section 16 and the end of the survey.

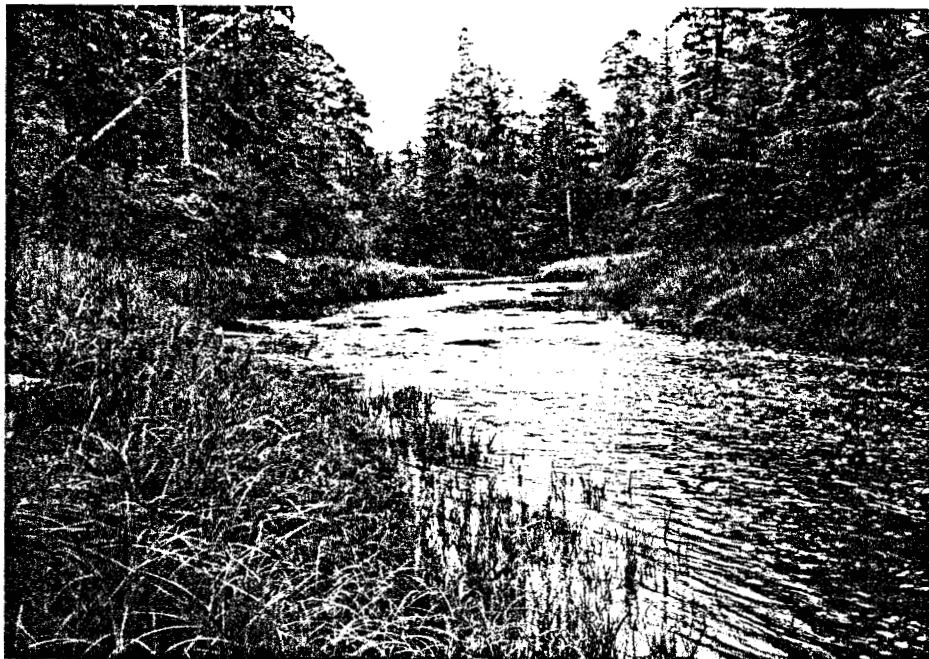
1. ITZ: An 80 m. stretch of possible ASA is present.

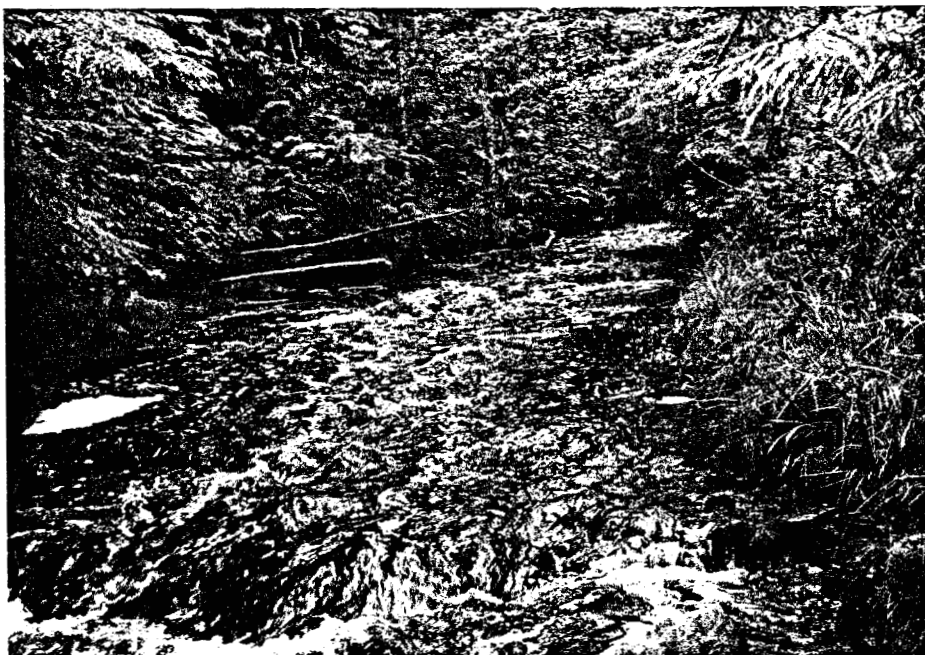
2. Little ASA or rearing area is provided.

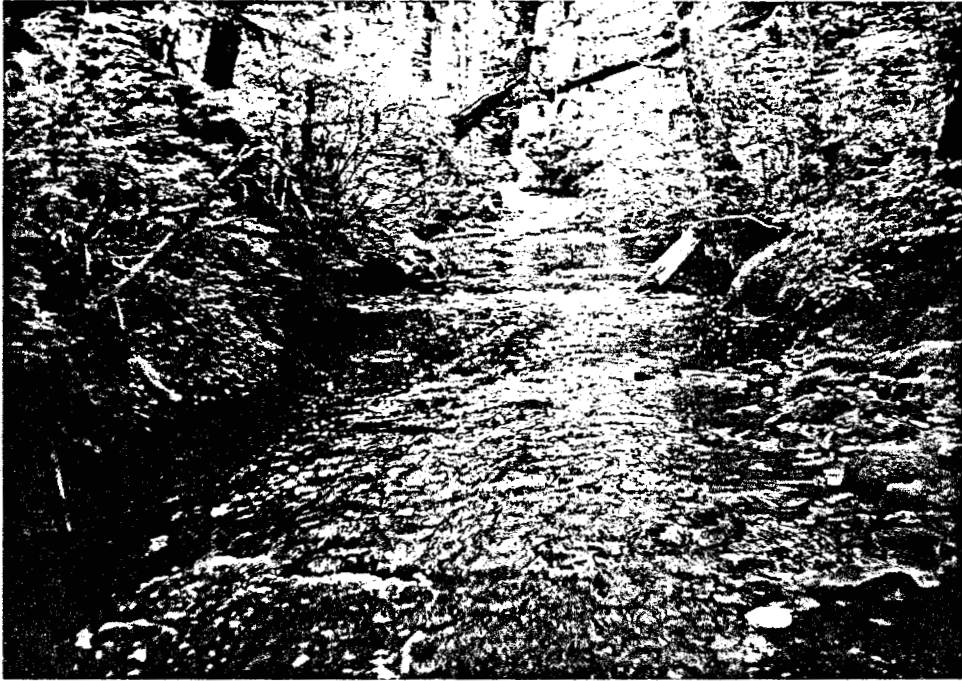
3. Typical poor habitat in Section 8.

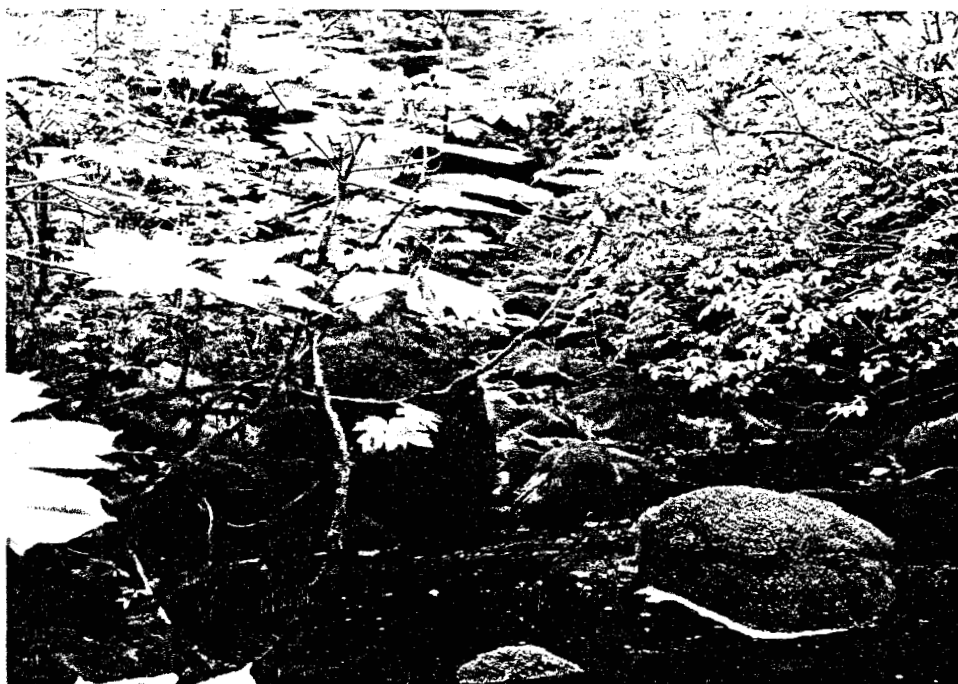
2. Habitat in Section 2 before the substrate turns to bedrock.

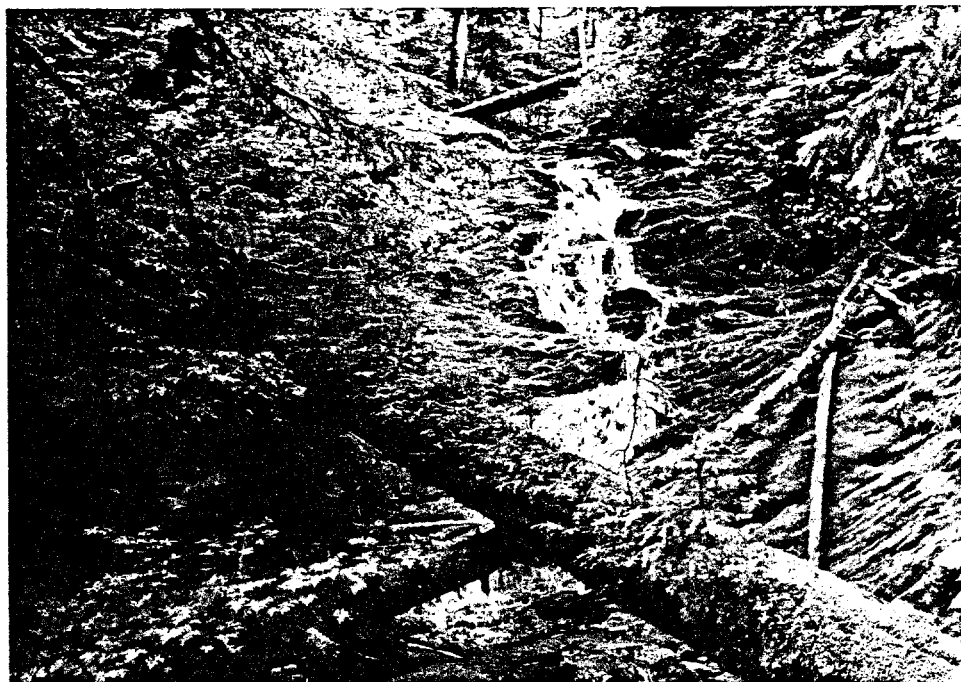
3. Bedrock barrier in Section 3.

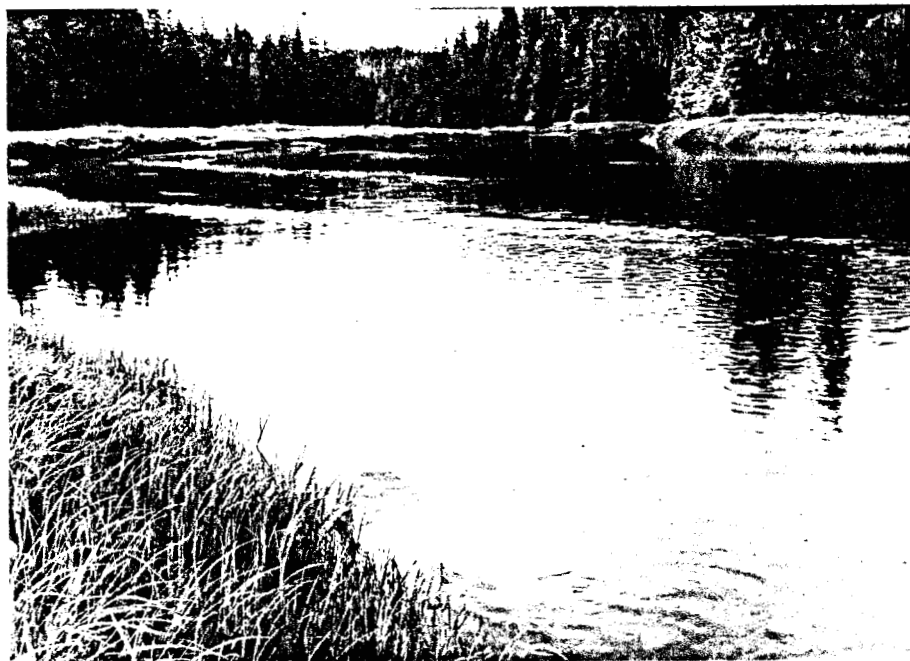
1. Lower ITZ

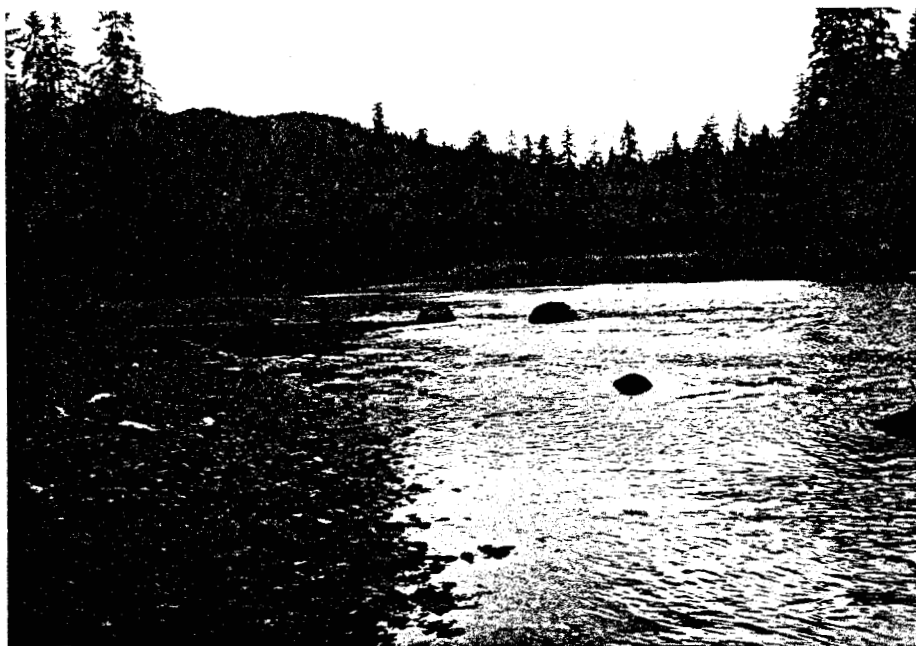
2. Section 1: The start of the survey is under tidal influence and contains good quality ASA.

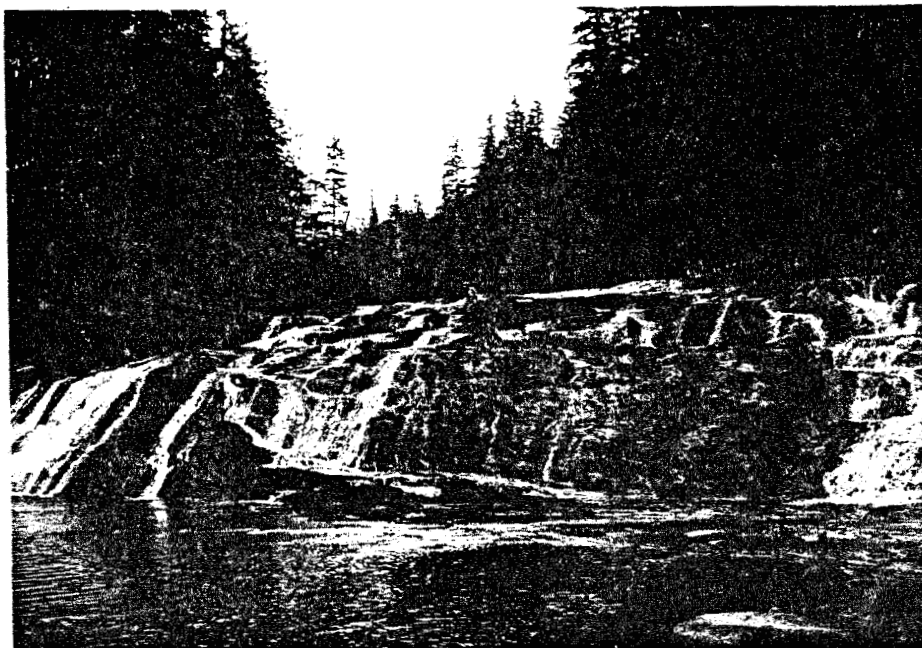
3. Barrier falls in Section 10.

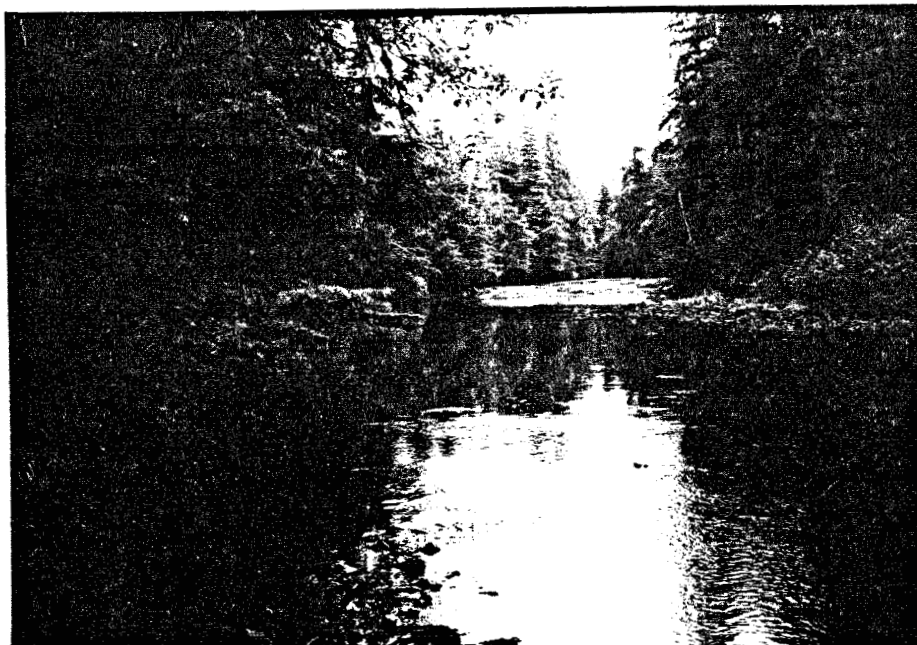
4. Section 25: A possible bedrock barrier due to low water depth in Section 27 is in the background.

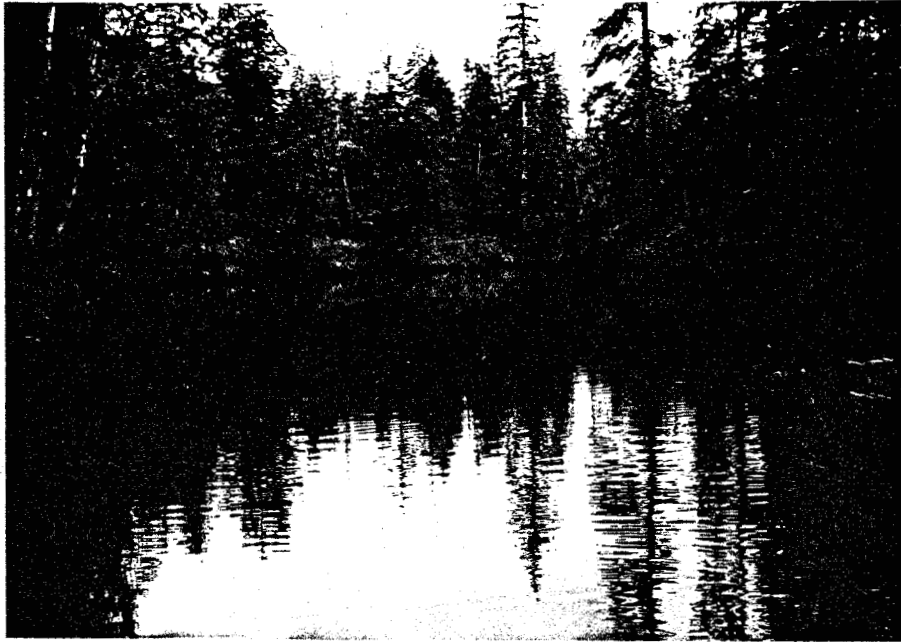
5. Section 30: The water is too deep and dark to survey further. Hofstad Lake is 400 m. upstream.

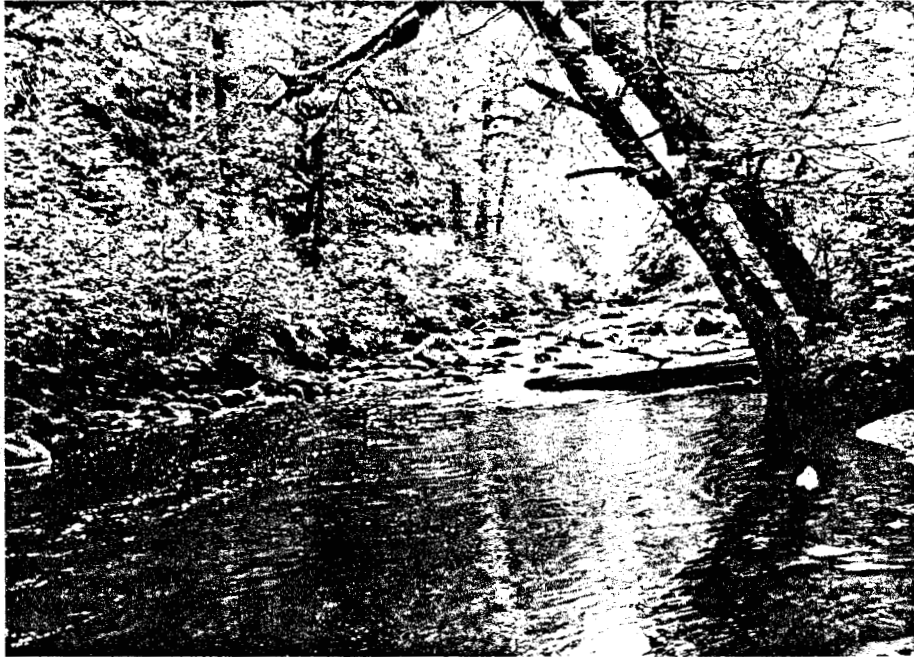
1. Section 3: The rearing areas lacks cover.

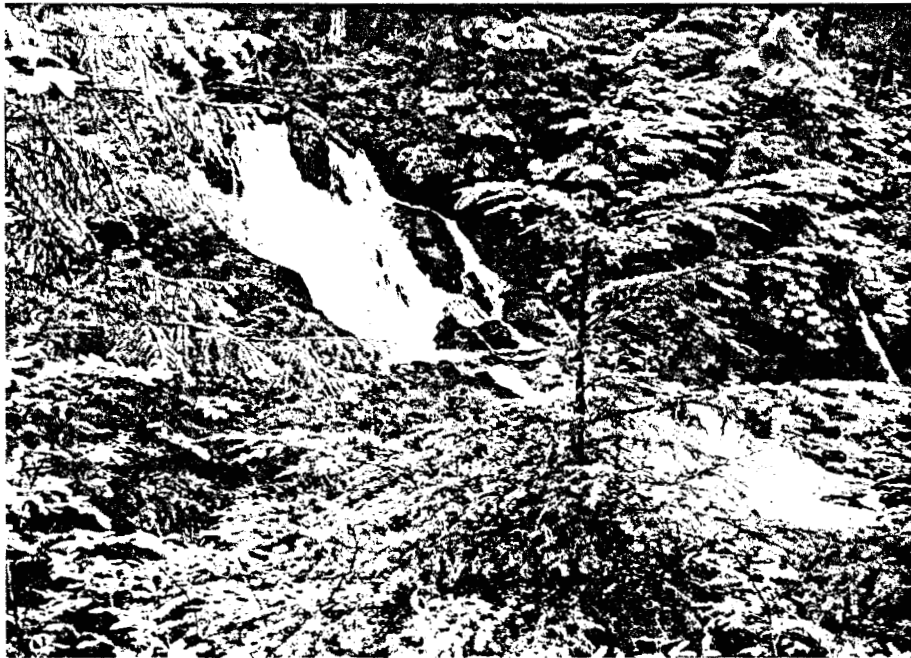
2. Second barrier falls on left fork in Section 5.

Section 5: The stream forks nearly in half 25 m into the section. The left fork has an estimated flow of about $.6 \text{ m}^3/\text{sec.}$ and has a 4 m barrier bedrock falls 100 m further upstream. The left fork averages 8 m in width and contains about 15% ASA. A second set of barrier falls is present 25 m above the first falls. The second falls is a two tiered bedrock formation with a 3.5 m and 5 m falls present. The steep bedrock upper banks appear to be very unstable around the falls. A helicopter reconnaissance above here found the stream forking and becoming whitewater. The survey continued up the right fork.

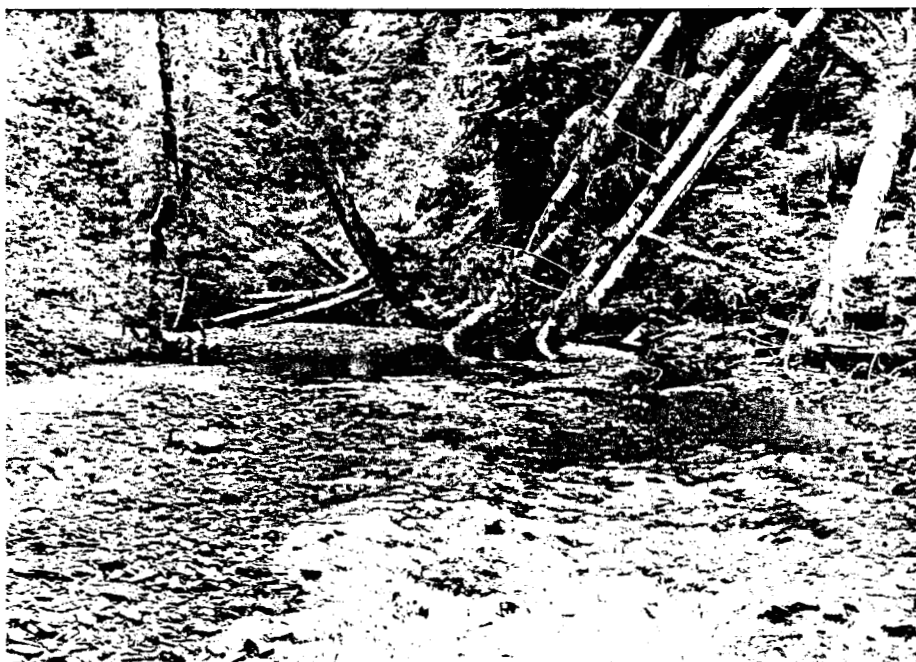
3. ASA and unstable upper banks in Section 9.

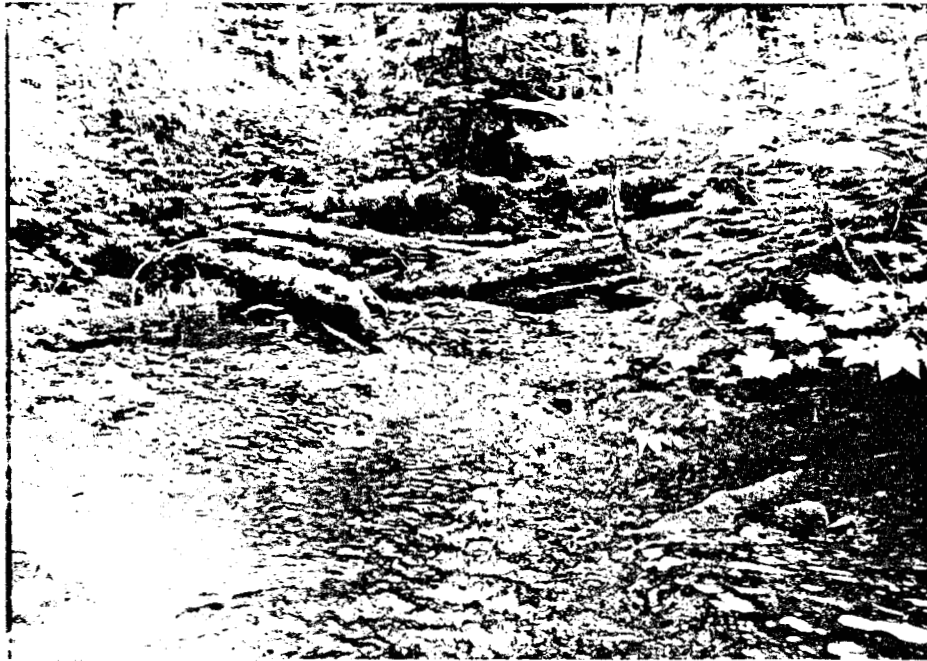
1. Section 2: The ASA was fair quality due to the flat substrate. A heavy debris load provided excellent rearing habitat.

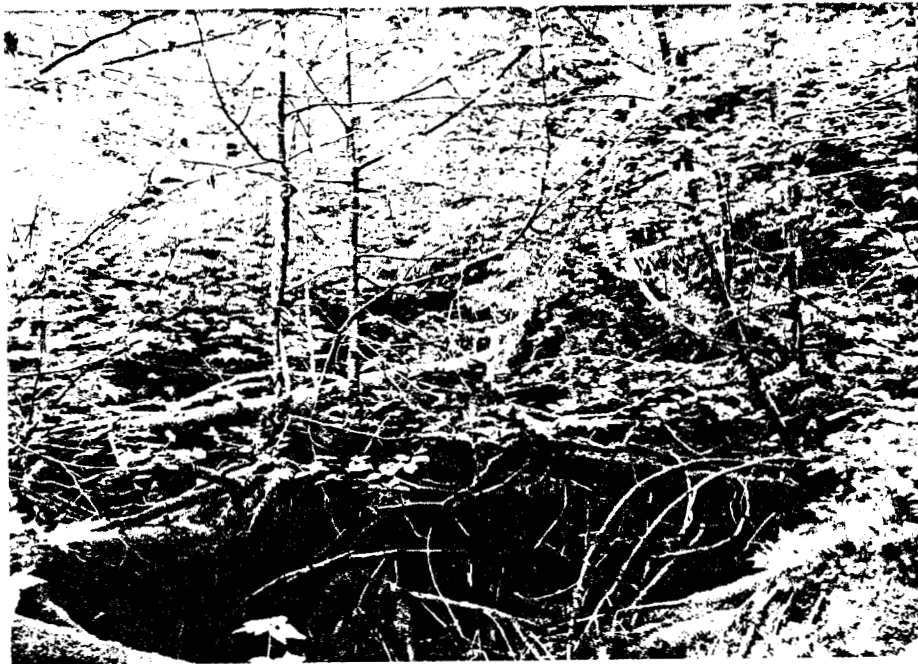
2. Severe blowdown and debris in Section 8.

Section 8: Fontinalis moss present. A great deal of blowdown from south winds are present on the steep unstable upper right bank in sections 8 and 9. An increased amount of fines were observed in the substrate near unstable areas.

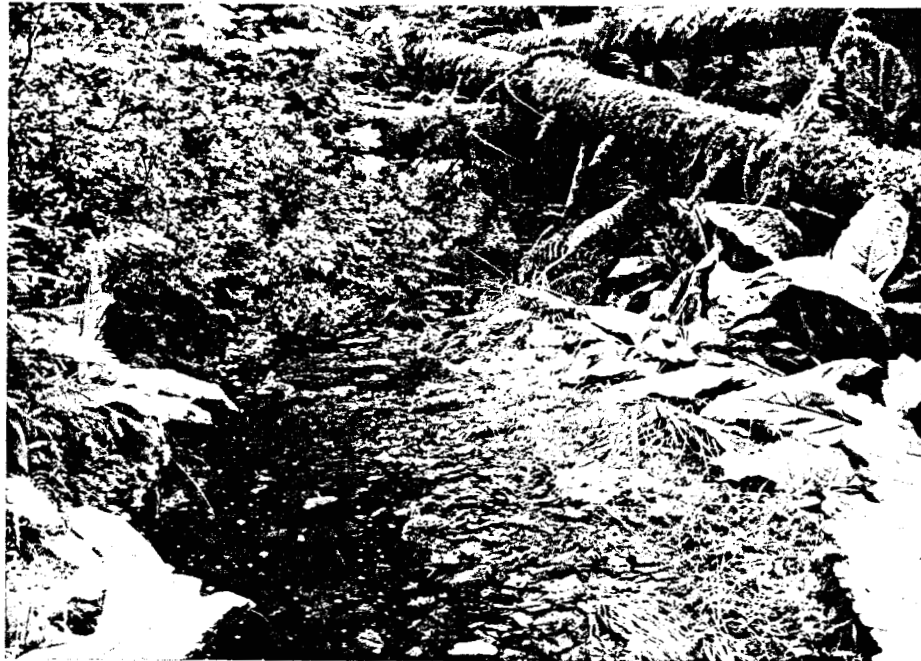
A tributary from the right bank in Section 5 contains fair amounts of poor ASA also. Excellent rearing habitat was present in the tributary, but no rearing coho were observed. No reason for the lack of rearing fish in this tributary could be deduced. Spawning PS were observed utilizing the silty ASA in good numbers on 9/3/84.

4. Flat, silty substrate typical of the ASA in the tributary to Section 5.
